#18-NA-144: Multiple Electrical Concerns, Intermittent Multiple Instrument Panel Cluster (IPC) Warning Lamps Illuminated, Intermittent Multiple Message on Drivers Information Center (DIC), Malfunction Indicator Lamp (MIL) Illuminated - (Mar 28, 2019)

Brand:	Model:	Model Year:		VIN:		Engine:	Transmission:
		from	to	from	to		
Chevrolet	Silverado	2017	2018			All	All
	Silverado LD	2019	2019				
GMC	Sierra	2017	2018				
	Sierra Limited	2019	2019

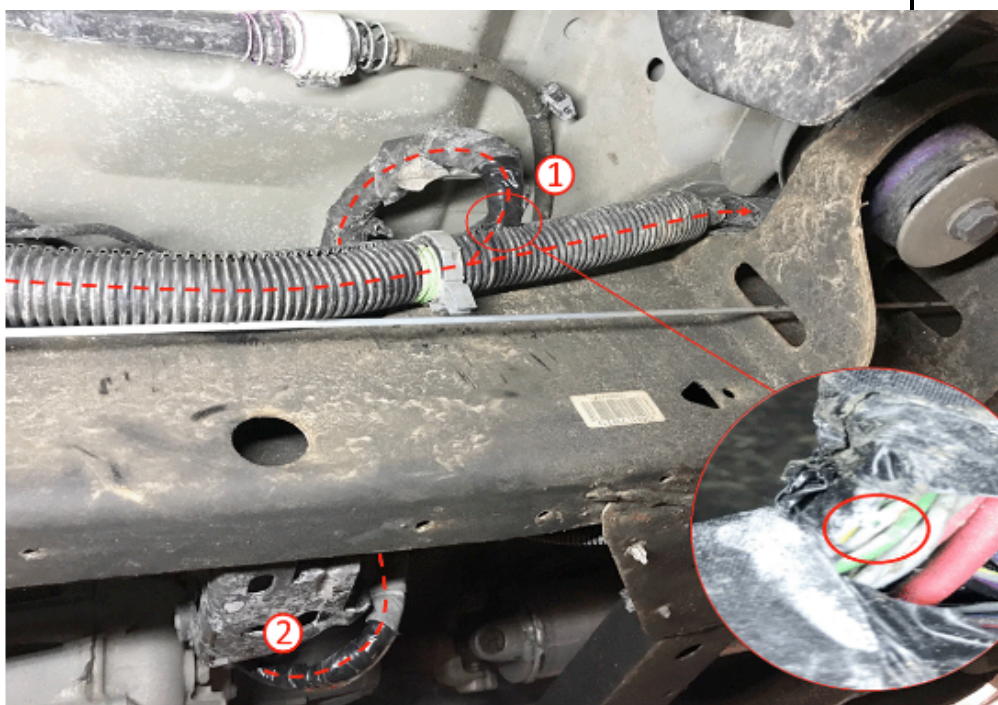
- Body (1)
- Rear Crossmember (2)

This condition may be caused by high resistance, opens, shorts and/or damage circuits in the chassis and electronic brake controller wiring harness.

⇒ Shown below are some areas to pay particular attention to:

Perform inspection of the wiring harness for any damage, opens, shorts, corrosion and contact with the chassis.

1. With a suitable light, inspect the wiring harness point of contact.
⇒ Refer to Wire to Wire Repair in SI (Document ID: 2161159).
2. Using Woven Polyester Electrical Tape (PET), tape all the contact points of the harness ensuring that the tape is applied in a double layer.

3. If required, reposition the harness away from area of contact.
